Fire Safety Risk Assessment

Holybourne Theatre
London Road
Holybourne Hampshire

FIRE RISK ASSESSMENT

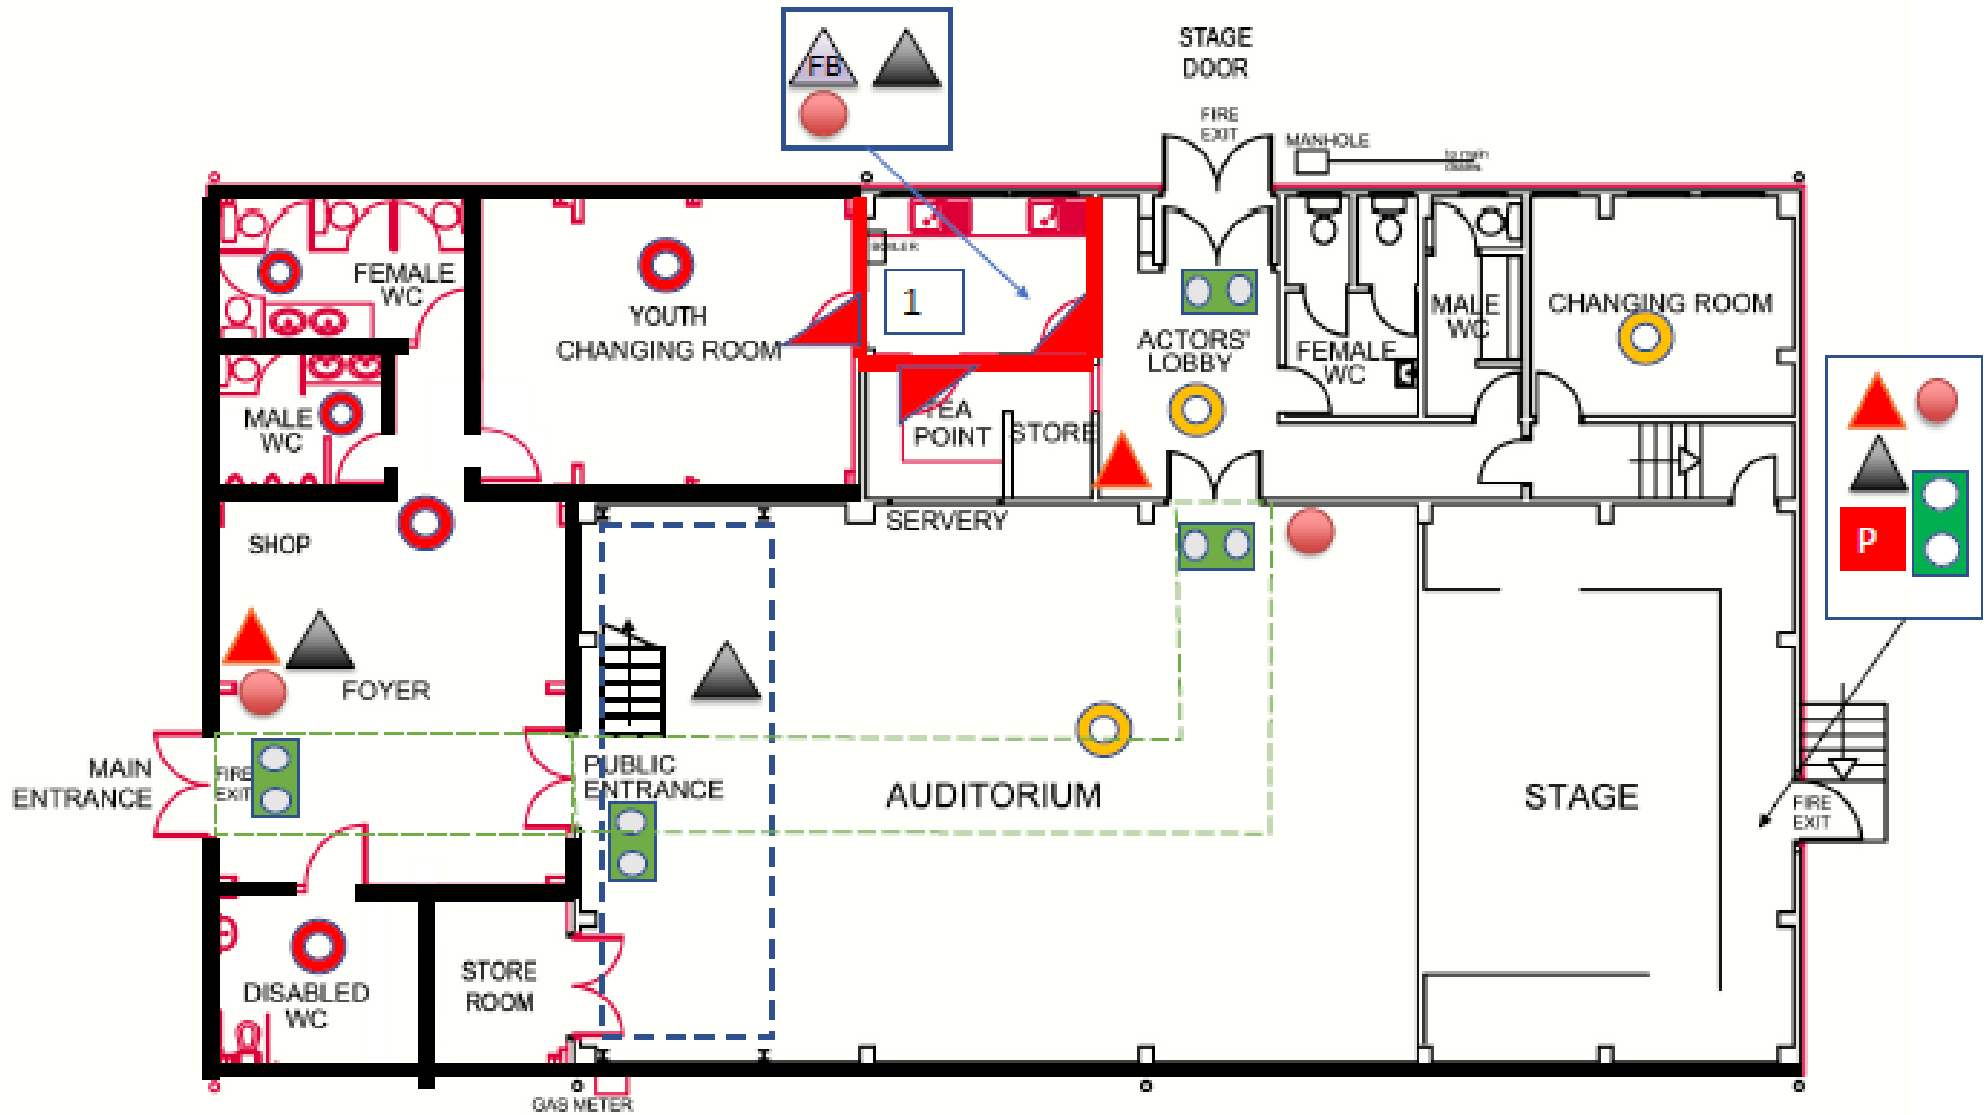
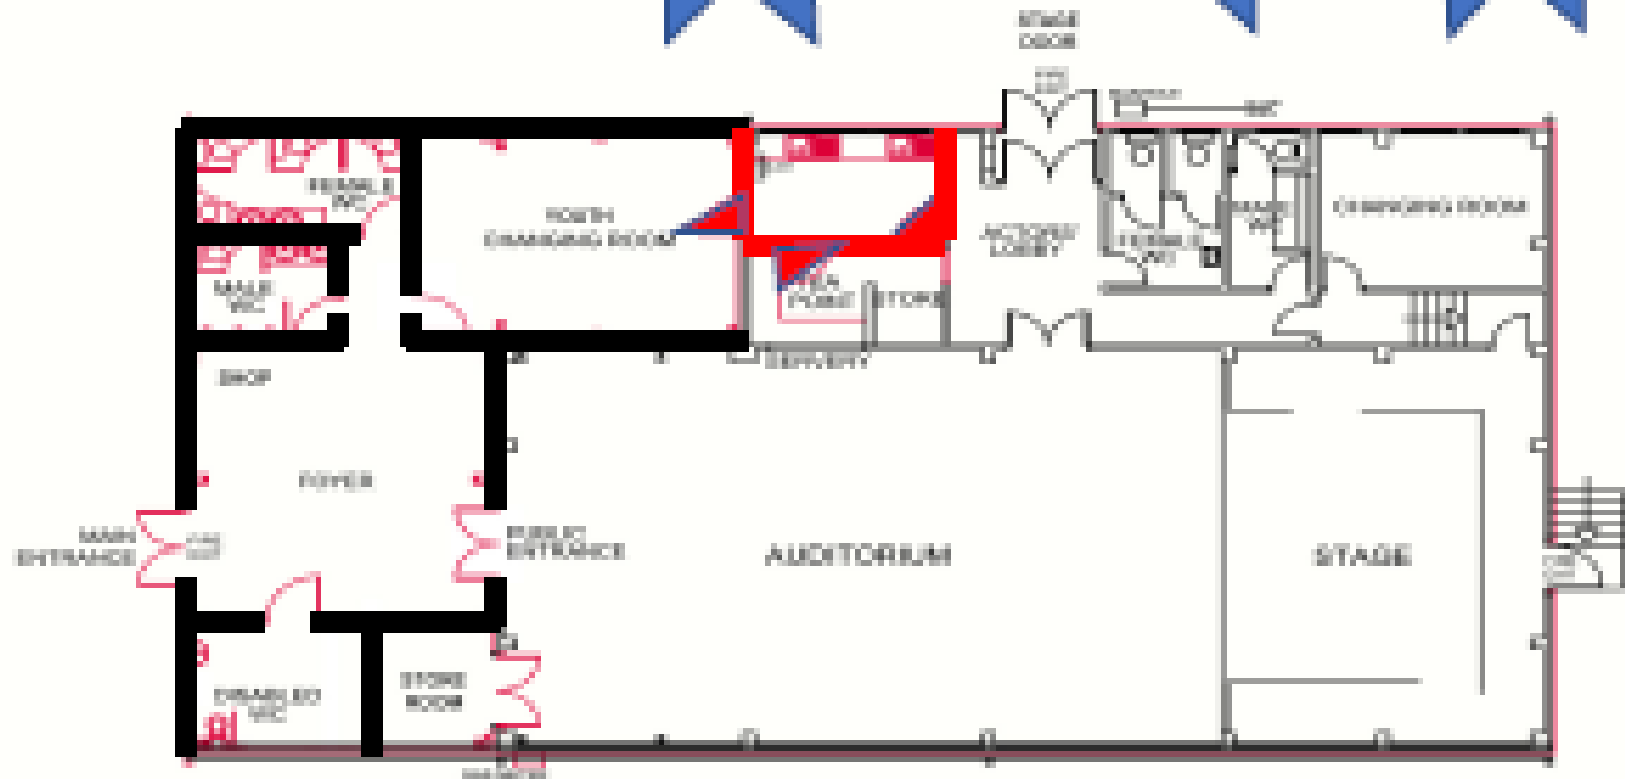
6 PLAN DRAWING

= door required to be replaced with a FD30S door or upgraded to FD20S

=Area to be provided with emergency lighting in accordance with BS 5266

= Minimum 1m wide passageway to maintained during performance
